ePMP™

Release Notes

System Release 3.5.1

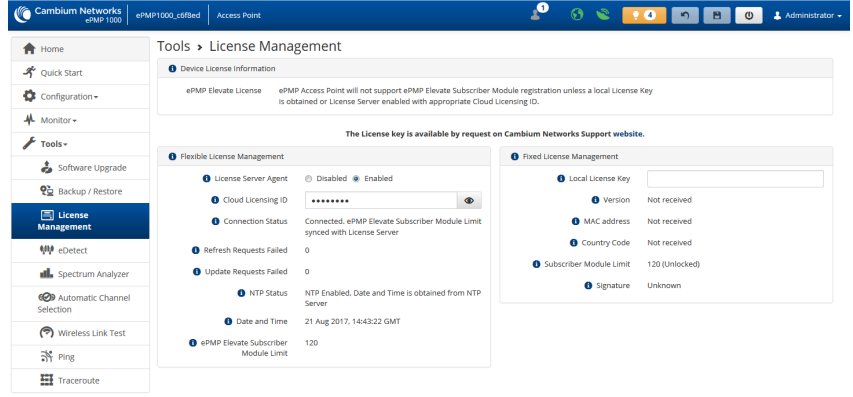
Elevate Flexible Licensing is available only for ePMP AP devices with GPS sync.

Country Code configuration for ETSI locked device and Full Capacity Keys for AP Lite devices are available only via Fixed License Management. Elevate is available via Fixed or Flexible License Management.
